# SolidFX

Inspection Report

Anytown, USA

SMH-11L901

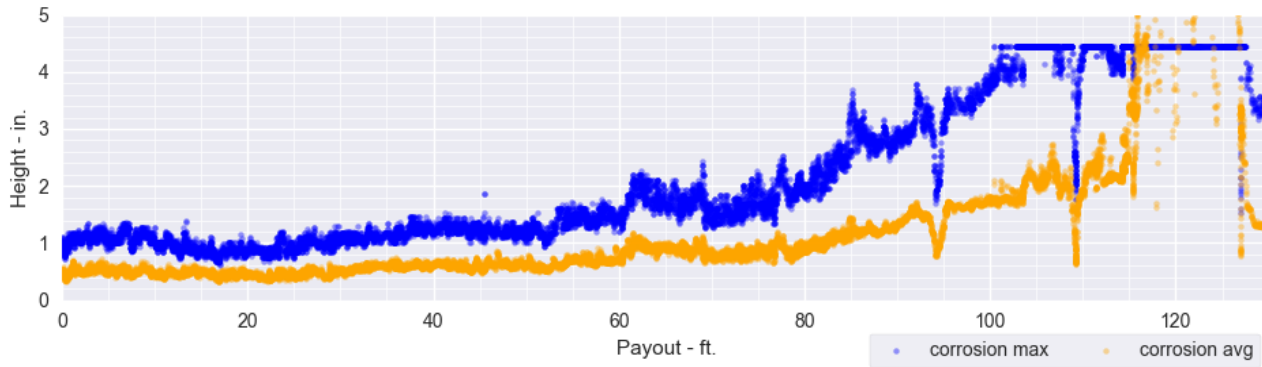
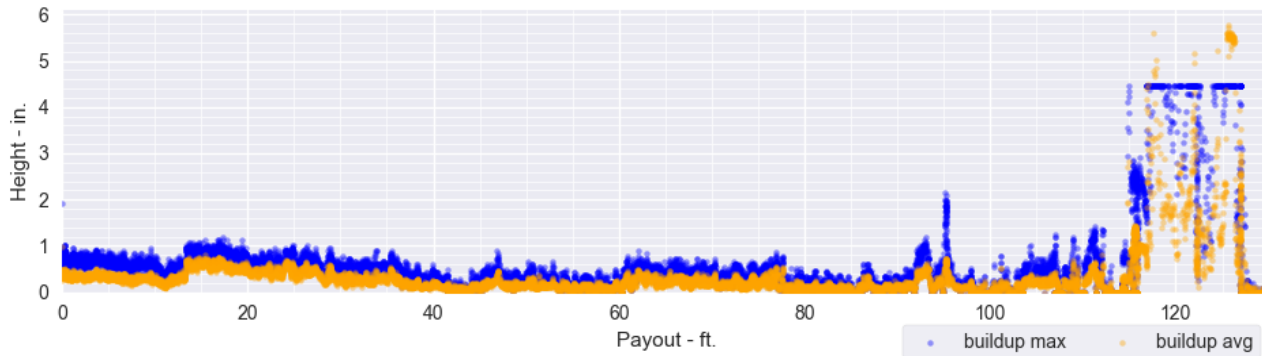
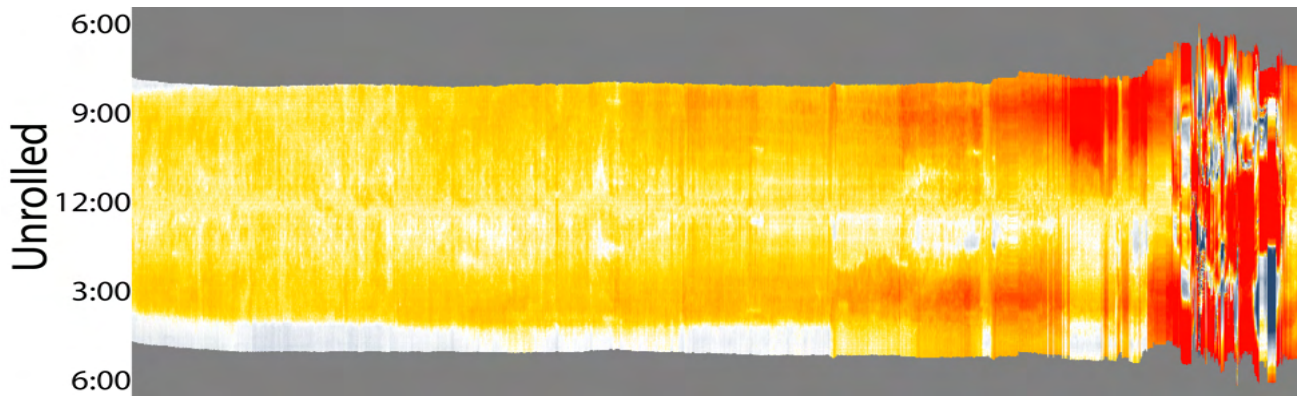
# Sediment and Corrosion Graphs(0'-130')

Corroded Volume (cubic in):	143948.4
Wall/As-built (%):	85.9
Average Wall Loss (%):	14.1
