Still Hard at Work

Compliance EnviroSystems continues the long and difficult task of restoring New Orleans area sewer systems after the 2005 hurricanes

COMPLIANCE ENVIROSYSTEMS LLC, BATON ROUGE, LA.

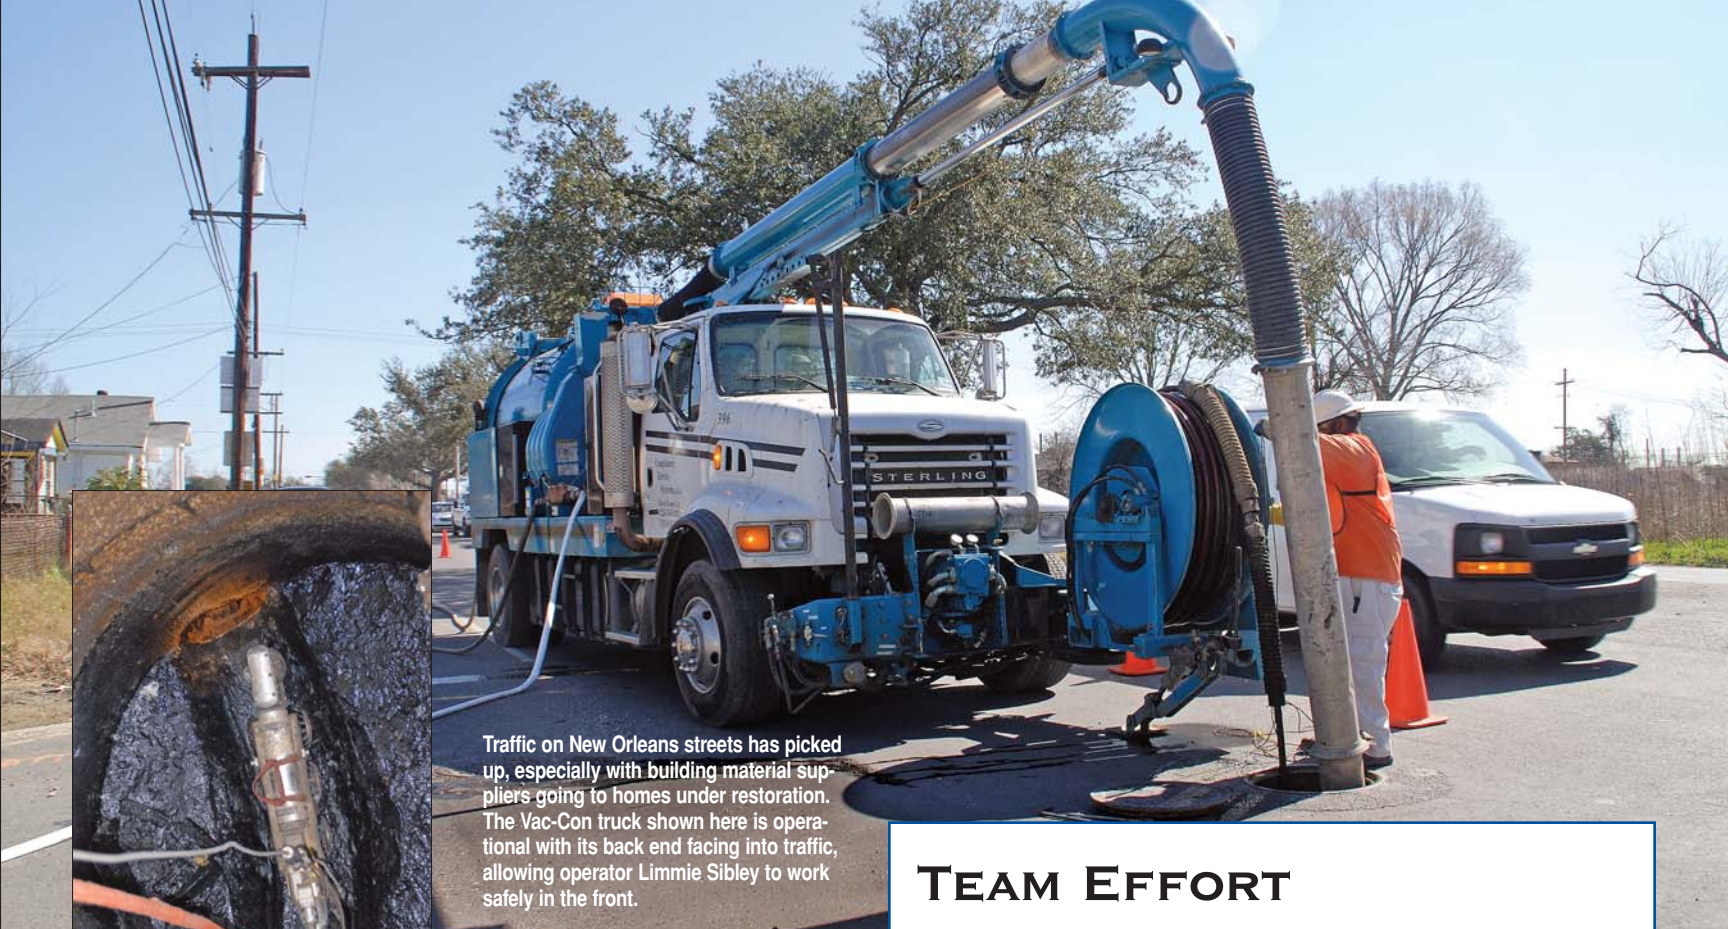
Traffic on New Orleans streets has picked up, especially with building material suppliers going to homes under restoration. The Vac-Con truck shown here is operational with its back end facing into traffic, allowing operator Limmie Sibley to work safely in the front.

Safety is paramount in all CES operations. Home says the Vac-Con machines can easily be placed in traffic with the back end facing oncoming vehicles, minimizing the operators’ exposure to danger. All controls are on the front of the truck.

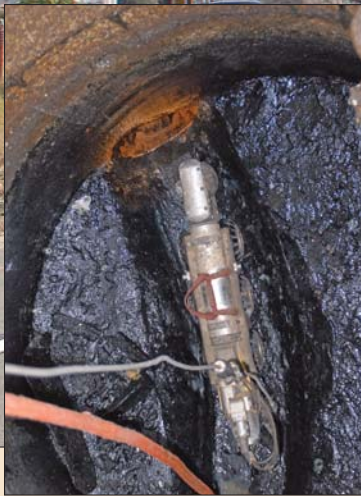
A camera from CUES Inc. is used to document sewer lines that have been cleaned.

CES personnel inspected sewers in the area using a CUES inspection camera coupled with that company’s Granite XP pipe survey and reporting software. Technician Bruce Walton manned the video monitor screens inside the CES inspection truck while operator Harold Knightshed handled the camera at the manholes. The two recorded video data in increments of up to 700 feet for later review and analysis. “Immediately after the hurricanes, we had all the help we could ask for,” says Dutruch. “Immediate recovery was an essential goal for the Greater New Orleans area.

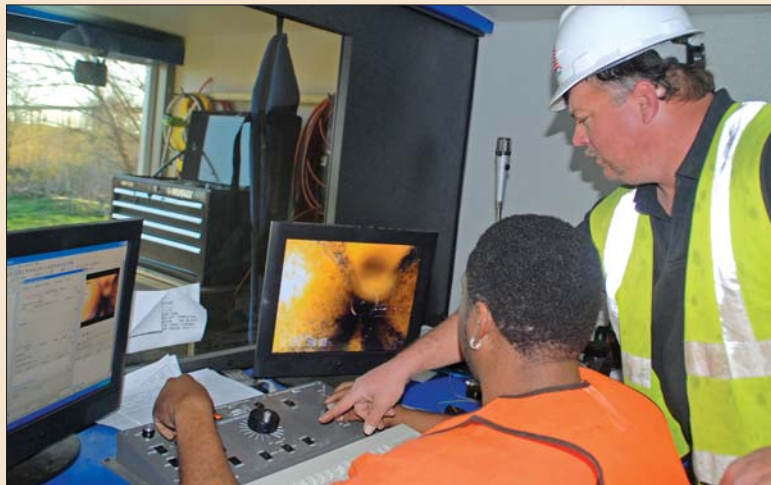
Technicians Bruce Walter and Paul Bordelon check video images in a camera truck. The camera collects data on runs up to 700 feet long.
