# ROOTS OF DESPAIR

**A contractor in eastern New York attacks a severe case of root intrusion with a custom-made cutting device and plenty of persistence**

**Remove five massive root bundles causing surcharging in a concrete sewer**

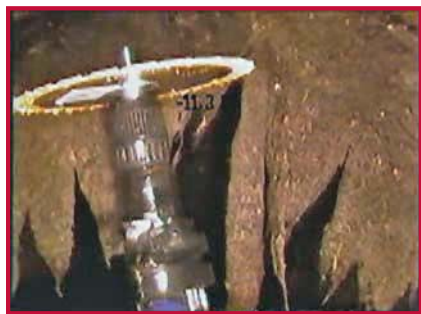
**Small, thin roots were easily cut with the 6.5-inch saw blade mounted on an air drill. These roots were not suspected to be the cause of pipe surcharging.**

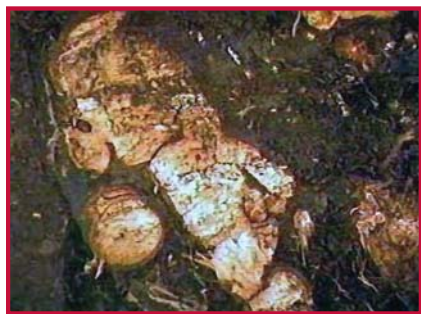
**A close-up of a trimmed cluster of tap roots.**

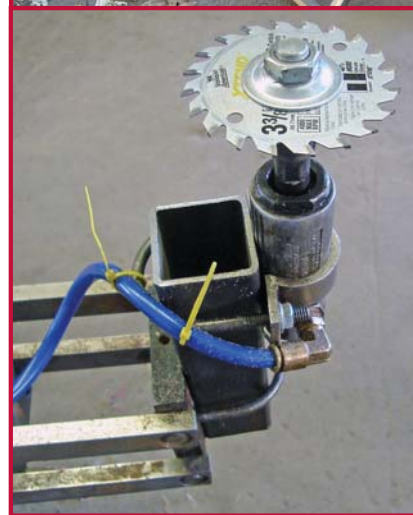
**The 3.5-inch blade is mounted on the high-speed air cutter motor.**

Normal reinstatement bits aren't designed to cut roots. "We bought a selection of 3.5-inch circular saw blades and arbors from a nearby home supply store," says Gardiner. The small blades, designed for battery-powered trim saws, were mounted on arbors with 1/4-inch shanks that fit the cutter's air motors. The motor, spinning at 22,000 rpm, provided three times the usual speed of a circular saw, but with minimal torque.

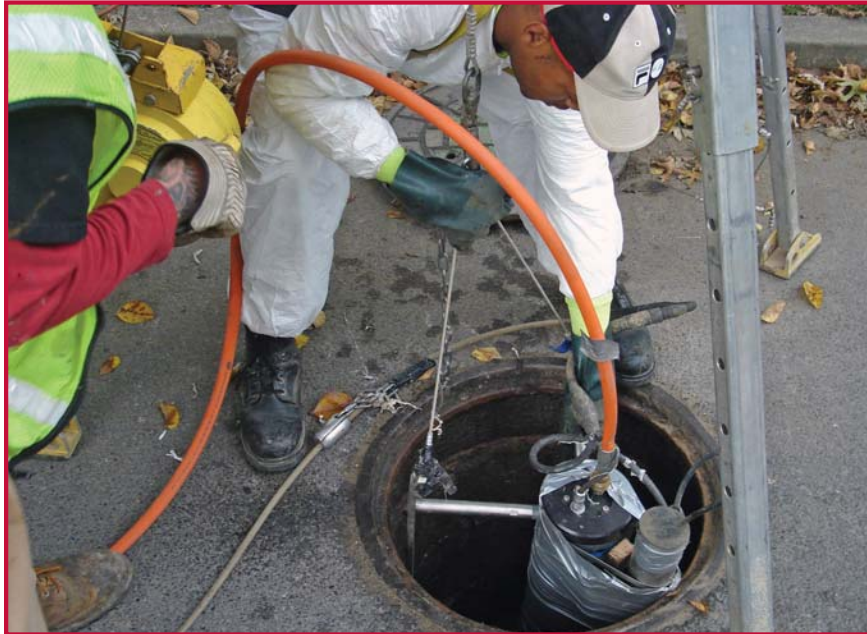
**Manhole openings limited the size of equipment used. High water flow prevented small component assembly at the bottom of the manhole. A tripod was used for cutter deployment and removal.**

Manhole openings of 22 inches with 4-foot corbels limited access to the sewer. "We discussed using bucket machines, but discounted them because they could damage or collapse the pipe, and we'd have to excavate," says Gardiner.
