Flying High

A Florida contractor uses a thermoforming PVC alloy pipe to reline culverts without disrupting heavy traffic on a naval air base

PROJECT:

Reline 2,042 feet of storm culverts without disrupting traffic

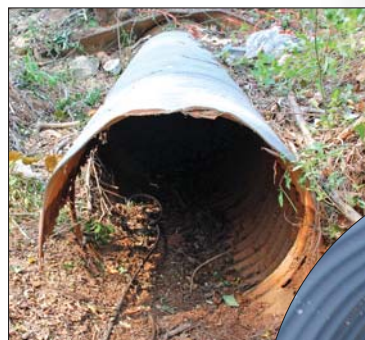
This culvert beneath a road had deteriorated badly.

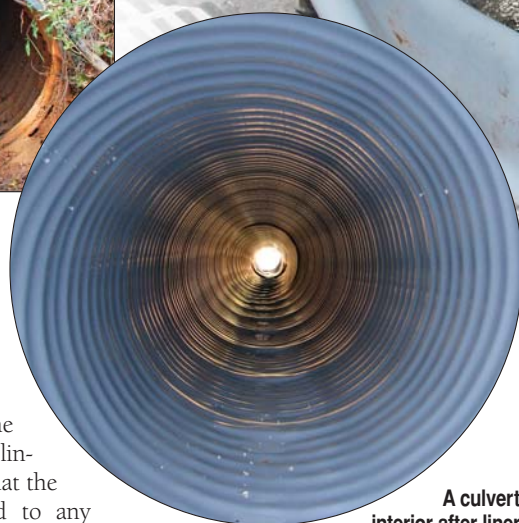
A culvert interior after liner installation. The liner fits so tightly against the host pipe that corrugation ripples are visible.

Once a liner was inserted, the men sealed the upstream end tightly against the host pipe with a flow-through sewer plug from Plug-It Products, then connected the steam hose. The heat relaxes the alloy and prevents post-installation longitudinal shrinkage. The crew then plugged the downstream end and

increased the boiler pressure to 18 psi to inflate the liner.

After the liner formed to the pipe, the pressure was reduced to 12 psi to hold it in place as an after-cooler blew in 80-degree air. “We monitor the temperature at the exhaust end,” says Pender. “Once it drops below 100 degrees, we turn off the pressure because the liner is hard enough not to collapse. The brass couldn’t believe how fast the process went.”
