DOING THE JOB IN-HOUSE

Putnam County saves time and money tackling the challenges of hilly terrain and a recurring hydrogen sulfide problem

By Dan Heim

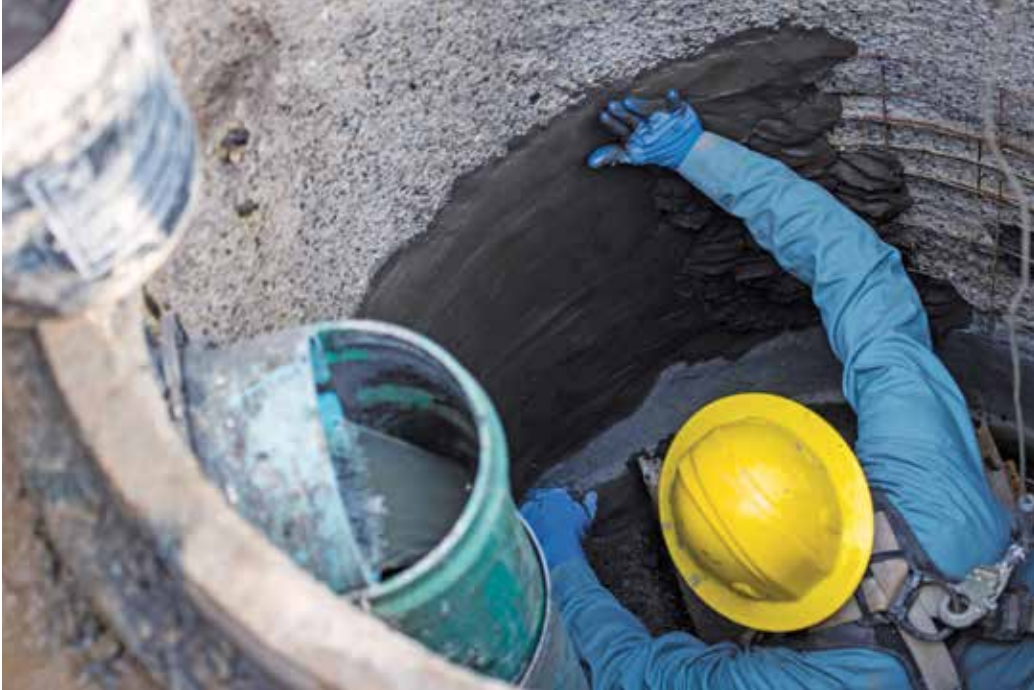
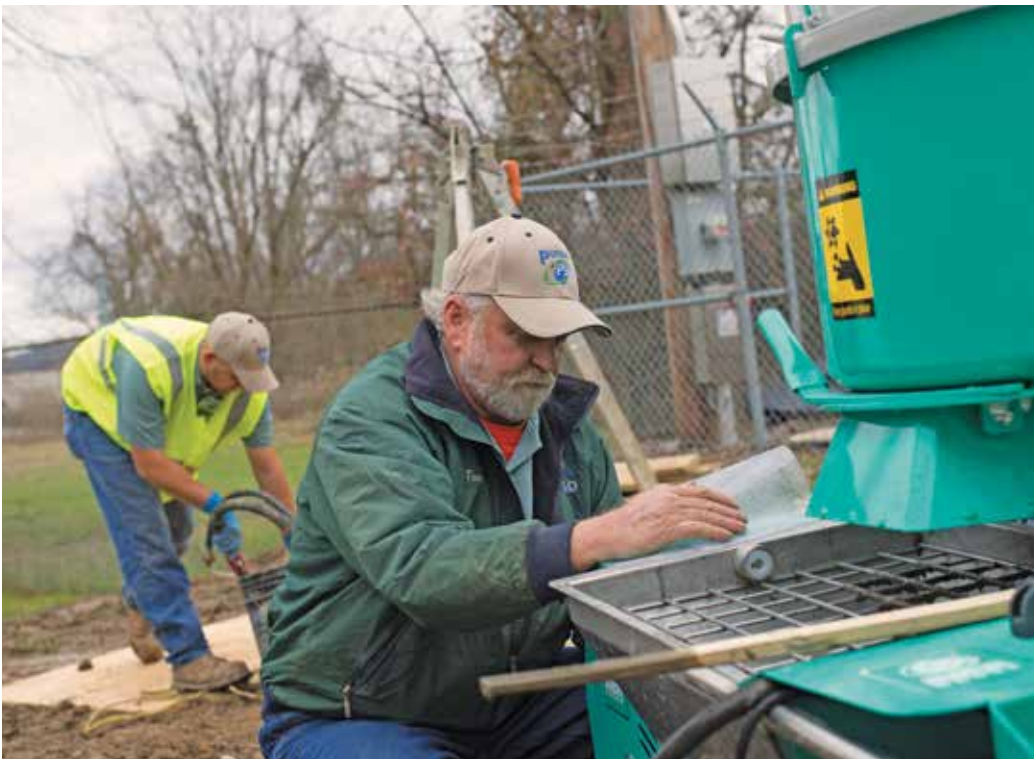
Top: Putnam Public Service District maintenance crew member Jeremiah Campbell applies grout to a manhole wall at Scary Creek Industrial Park in Scott Depot, West Virginia. **Above:** Tom Forth pumps grout through the Step Up 120 (Imer Group) grout pump and spray machine while his crew sprays the inside of a manhole.

“We went with a manhole lining system based on aluminum nitrate,” notes Forth. “It had one of the best ratings for resistance to corrosion. So the first 11 manholes were subbed out. When I watched the process, with my construction experience I knew we could do that in-house. So I went to my boss and he gave me the green flag.”

What they got was an increase in speed and a decrease in cost. When they subbed out that job they were paying about \$300 per foot. When they tried it in-house applying the lining by hand, that cost dropped to \$177 per foot. But it was difficult work, with the 13 manholes they tackled ranging from 8 to 14 feet deep.

“That work nearly killed us,” recalls Forth laughing. “So I started some research and decided to buy that grout pump from Parson Environmental. It got our cost down to around \$130 to \$140 per foot.”
