## A BETTER VIEW OF YOUR INFRASTRUCTURE

Digital side-scanning technology offers rapid condition assessment, enabling more informed decisions

By Chris Parker

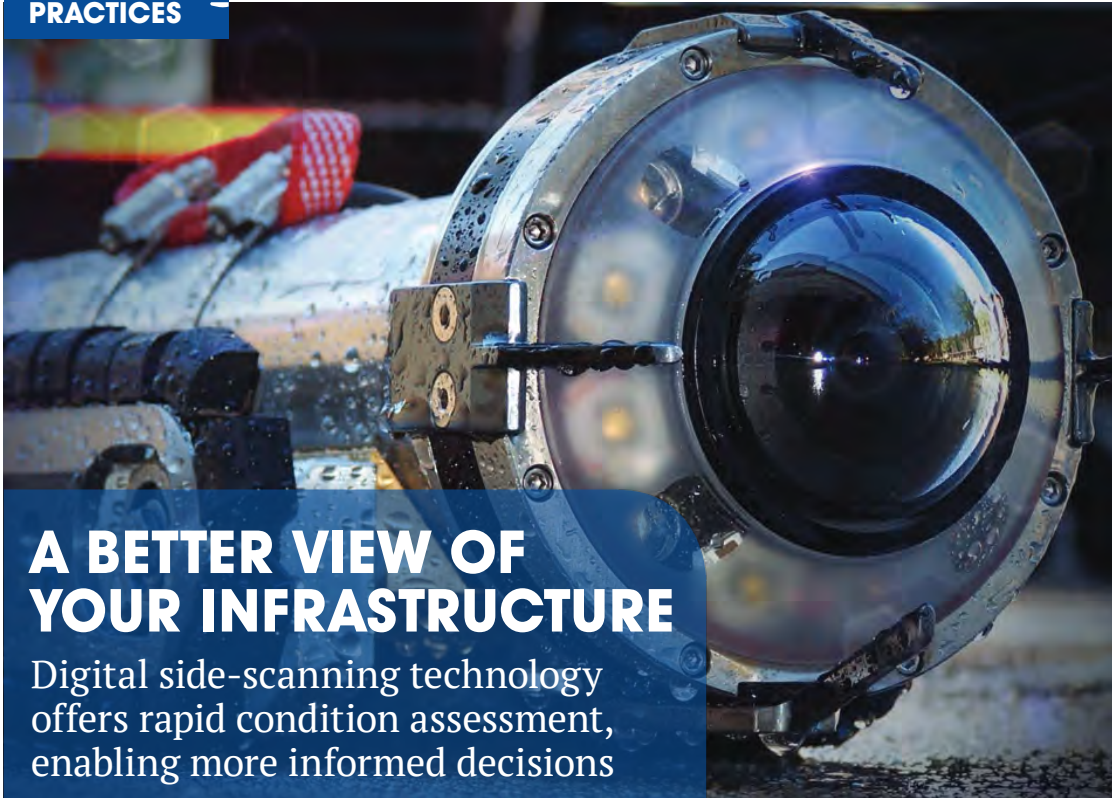
Digital side-scanning is becoming more common as municipalities embrace new technologies that enable rapid assessment of pipelines and provide high-quality data to efficiently quantify repair and replacement needs.

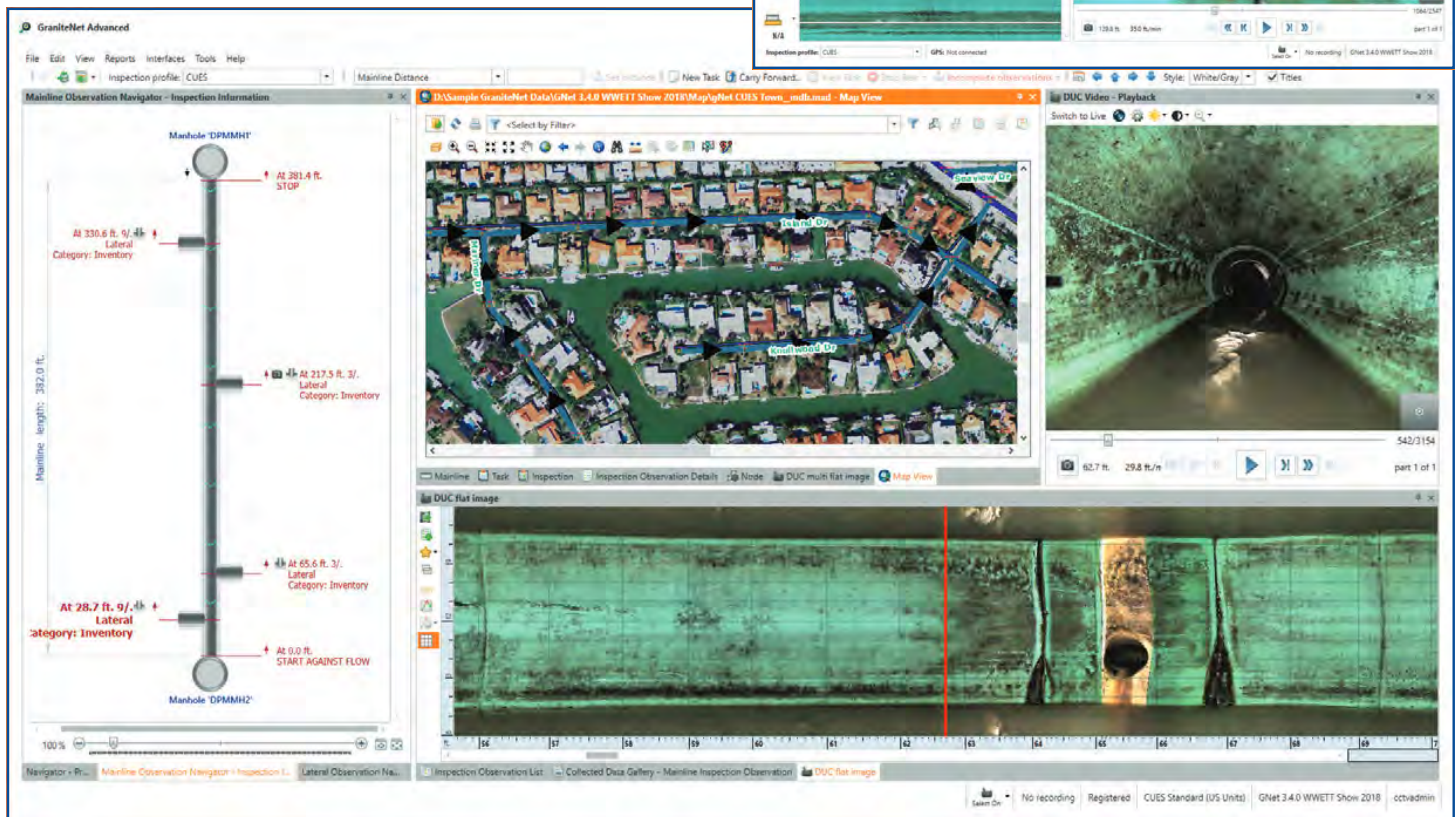
Side-scanning camera systems work by capturing several images per second, which are then stitched together, producing three deliverables: high-resolution video, a flat unfolded view of the pipe from manhole to manhole (multiflat view), and an expanded flat unfolded view of the pipe for close-up views and measurements of defects.

The technology works by capturing several images per second, which are then stitched together, producing three deliverables: high-resolution video that is a permanent and accurate record with the ability to virtually pan, tilt, and zoom to any area of interest; a flat unfolded view of the pipe from manhole to manhole (multiflat view), and an expanded flat unfolded view of the pipe for close-up views of defects and to perform measurements.

The flat view provides the ability to quickly inspect and review thousands of feet of pipe in a matter of hours instead of days, allowing you to make the best use of the one resource that is not replaceable ... time.
